May 15, 1992

TO ALL EXEC 90 BUILDERS

EXEC 90 MANDATORY COMPLIANCE BULLETIN M-04

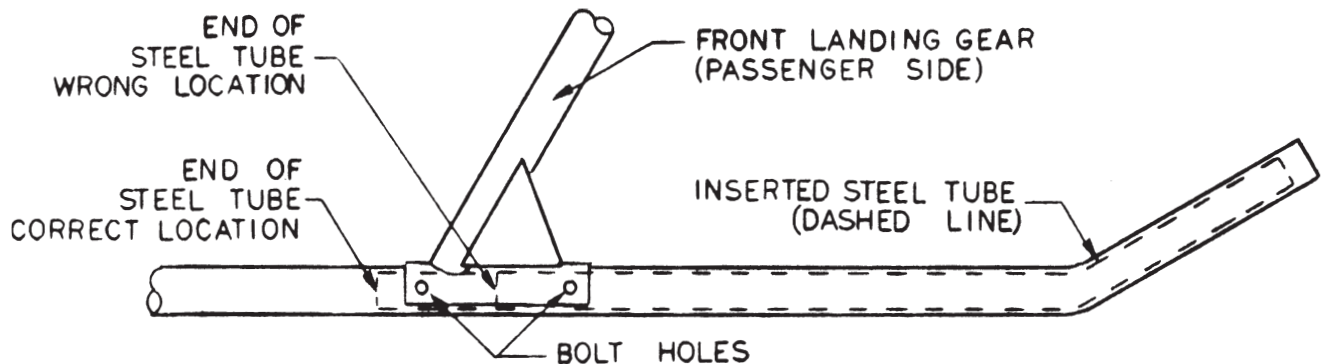
History: The passenger side landing gear skid is reinforced with an inserted 4130 steel tube to strengthen the area for ballast weight mounting. Two holes are drilled through the skid to bolt it to the front landing gear. Both of these holes **MUST** pass through the inserted steel tube.

In some instances the steel tube may not extend far enough to the rear to intersect with both bolt holes. (See drawing below.)

Action: If both bolt holes do not pass fully through the inserted steel tube, return the skid to RotorWay International for replacement.
