May 15, 1992

**TO ALL EXEC BUILDERS**

**EXEC ADVISORY SERVICE BULLETIN A-10**

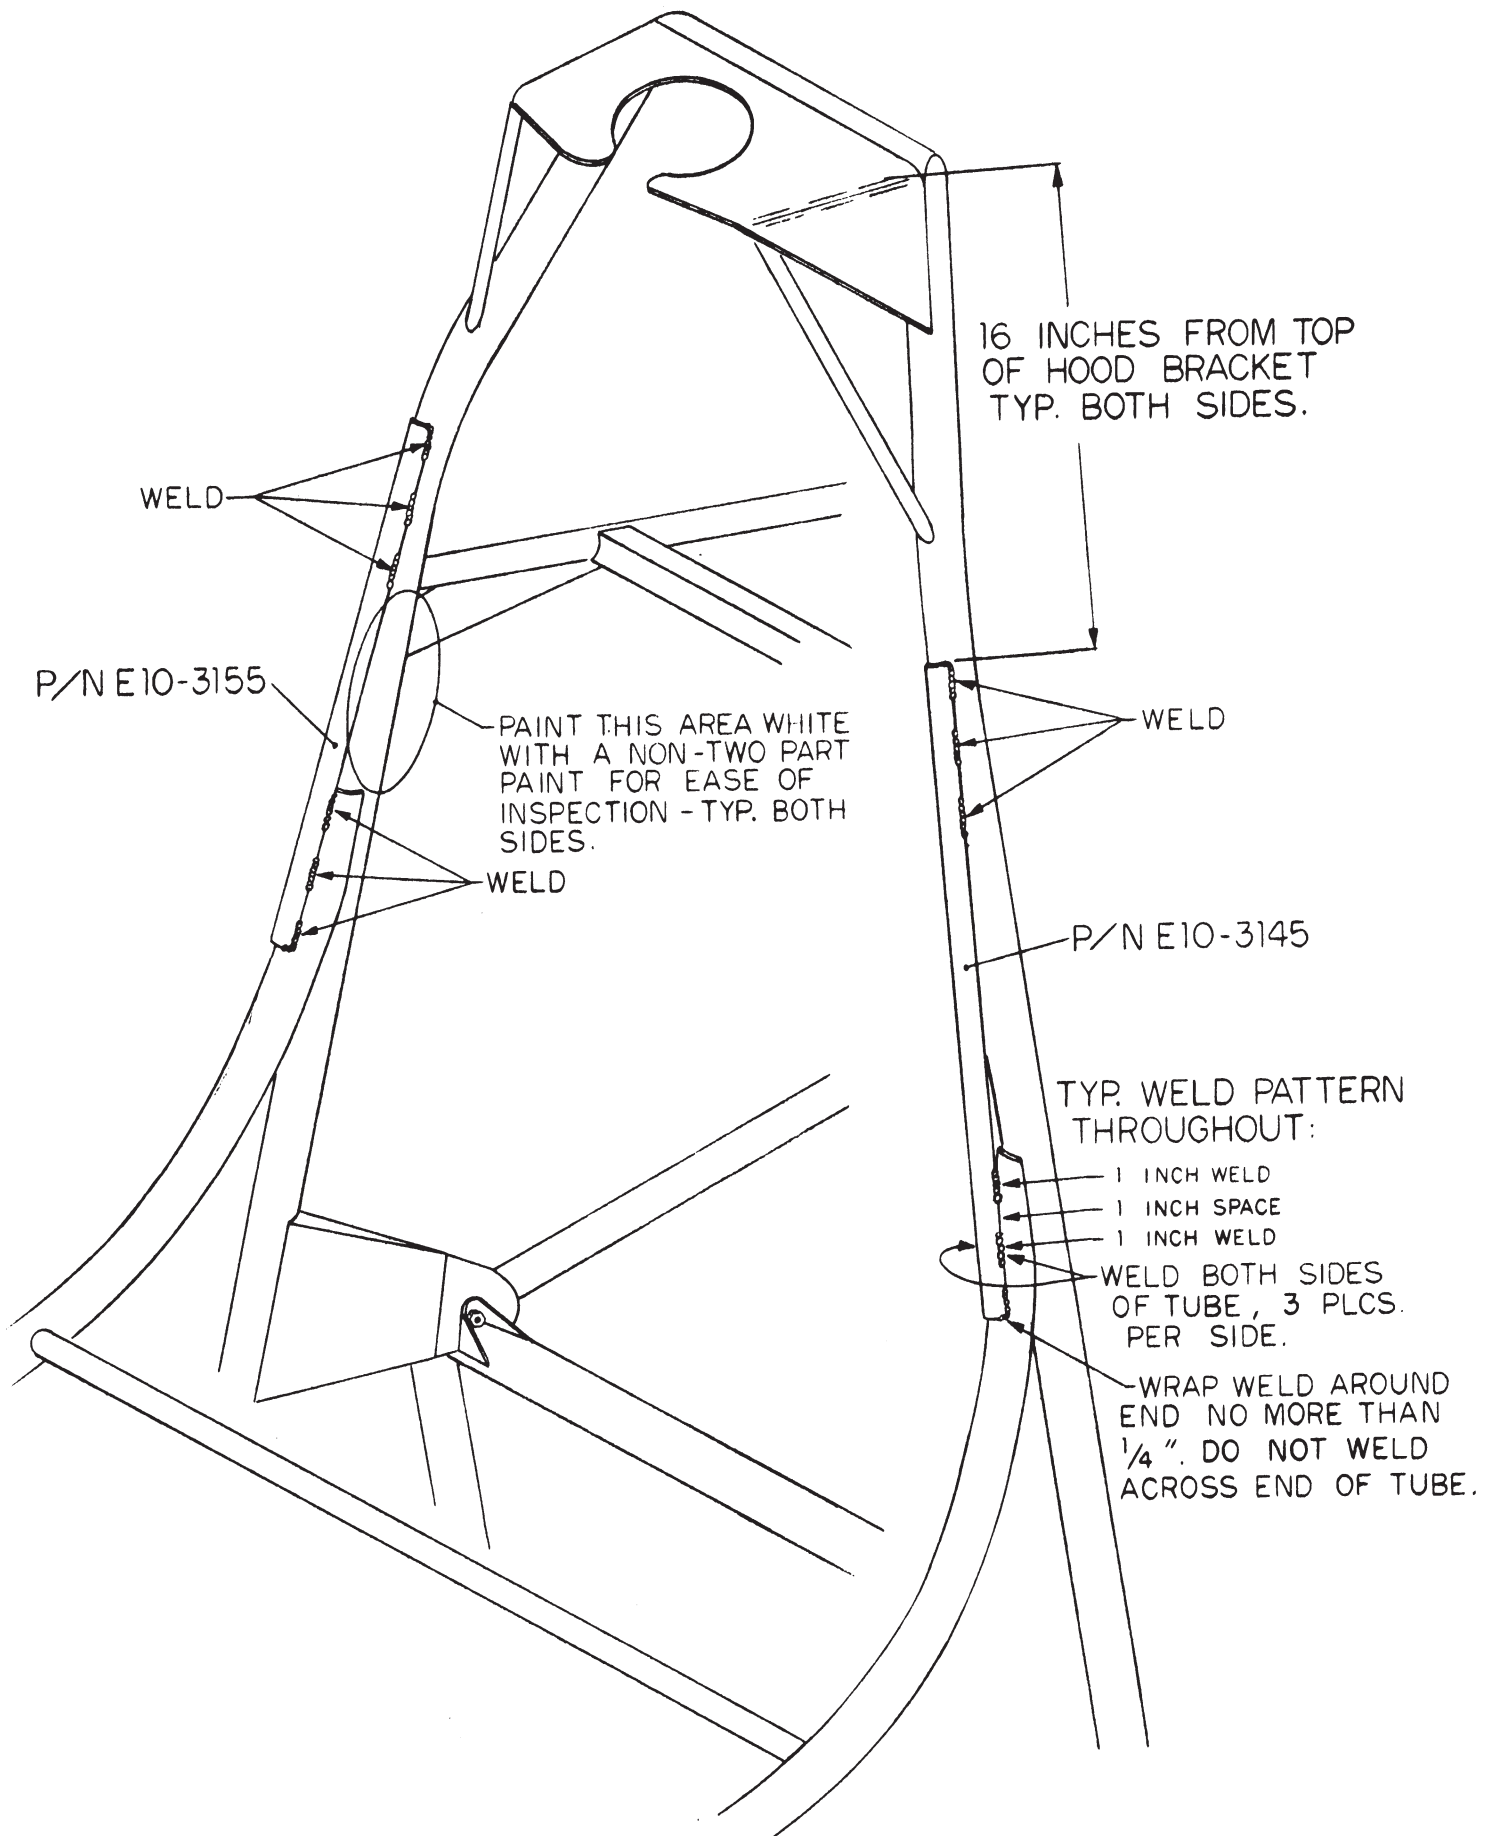
History: Two EXEC airframes have had the vertical support tube E10-3160 and E10-3170 fatigue and crack in half.

**WHEN THESE AIRFRAME TUBES CRACK IN HALF, THE AIRFRAME SEPARATES AND REMAINS HELD TOGETHER ONLY BY THE GAS TANK STRAP. THE FRAME WILL OPEN ENOUGH THAT THE PILOT WILL LOSE CONTROL OF THE ROTOR SYSTEM. THE BLADES WILL GO TO POSITIVE PITCH THAT IS UNCORRECTABLE BY THE PILOT.**

Both EXEC aircraft with airframe failures were involved in extensive trailering. This cannot be isolated as the only cause for fatigue but may certainly accelerate the condition.

Action: Installation of tubes E10-3145 and E10-3155 is strongly recommended for all EXEC airframes. These formed 1 inch diameter tubes are designed to improve the stress distribution on several sections of the airframe.

We recommend the removal of all paint around the modification area. After the welding is complete, use a thin coat of a light color single part paint to facilitate airframe crack inspection.
