RotorWay International

To: All Talon owners and all owners that have a tail rotor drive shaft.

Subject: Mandatory Compliance Bulletin M26

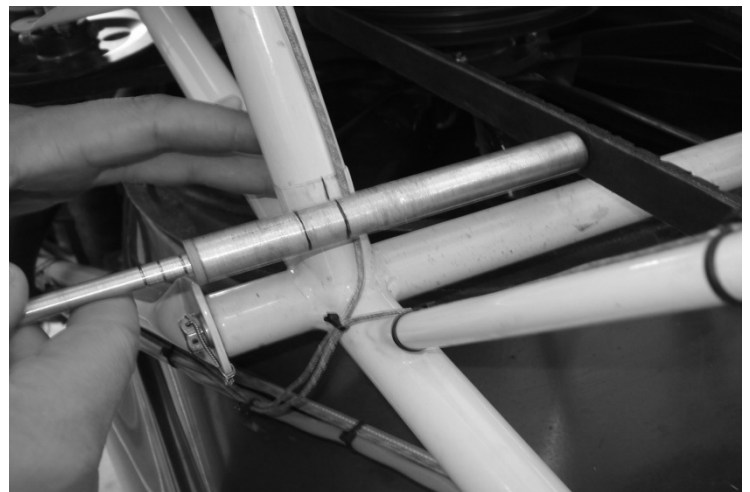
Photo #15

Spring tensioner (E49 CARD 3T) is used to set belt tension. Adjust tension arm stop until 7 lbs. is reached at a 1/2" travel. The first of three lines on the tension tool will be 7 lbs. Verify this by pushing tool against known accurate scale. The tension tool is adjustable. To adjust remove locking allen in end of tool. A second allen will adjust spring tension.

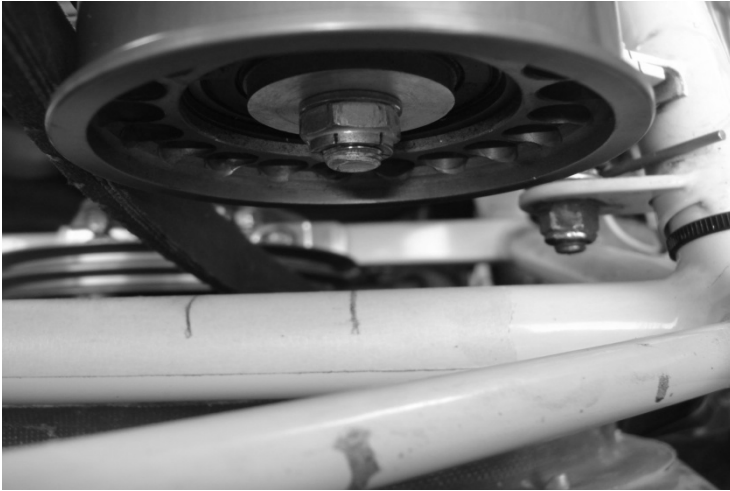
Photo #16

When correct belt tension is set (be sure the tensioner is held against the stop by the belt), mark the center of the pulleys bolt below on airframe.

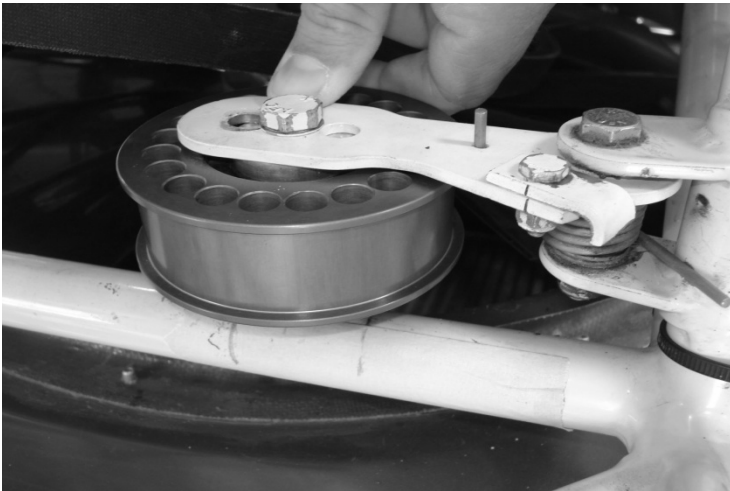
Photo #17

Remove tail rotor belt. With pulley extended straight out, mark the center of the pulleys bolt. Minimum distance is 3/4" between lines. If less than 3/4" move pulley bolt to outer mounting hole. After replacing belt recheck tension per photo #15 and be sure pulley does not touch the frame.
