A600 TALON MAINTENANCE MANUAL

The RotorWay A600 TALON Maintenance Manual has been designed to provide the owner-operator the lowest operating cost possible while maintaining the flight characteristics and safety of their helicopter.

JANUARY 23, 2009

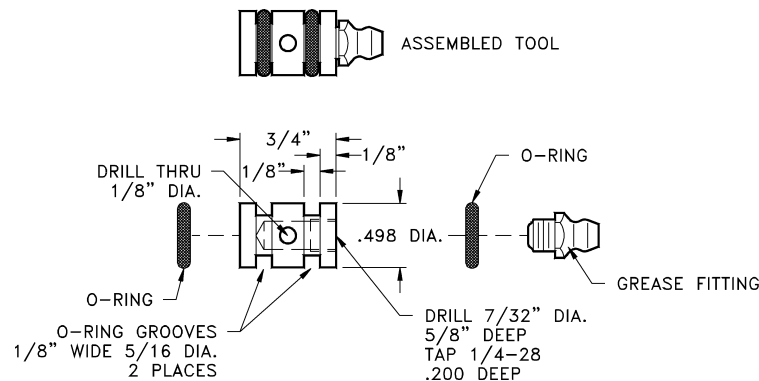
6. A simple tool can be made to add grease to the aligner block bearings (part number E20-1220) as shown in the drawing below. This tool will enable you to grease the bearings with the blades removed and the aligner blocks in place on the blade straps. Make the tool from steel or aluminum. Using this tool at the 100 hour maintenance interval will allow you to increase the recommended change out time of the bearing from 100 hours to 200 hours or on condition.

Insert the tool into the bearing. Pump the grease until it visibly comes out of the bearing, purging out the old grease. Wipe away the excess grease, then rotate the inner race of the bearing (using a deep socket on the grease fitting) to spread the new grease and to make sure the bearing turns freely.

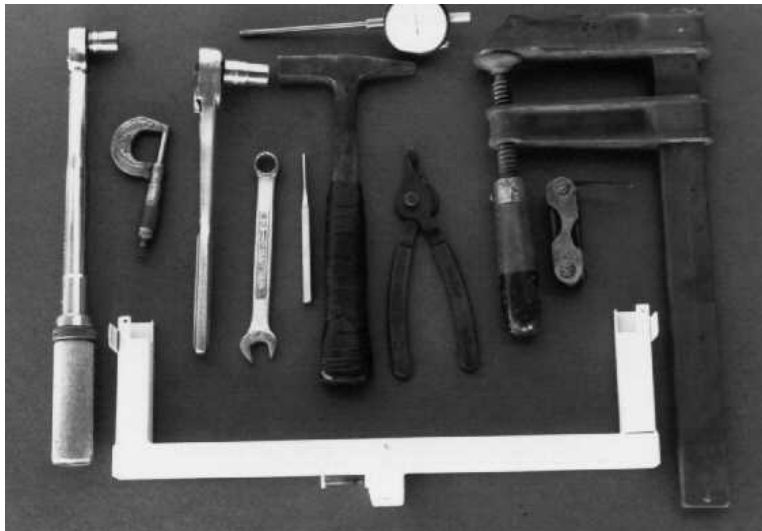
Photo #1: Tools required.

1. The following tools are required to perform the hub shimming procedures:
 - 3/8" torque wrench in ft. lbs. capable of 30-35 ft. lbs.
 - micrometer in thousandths of an inch
 - 3/8" drive ratchet with 9/16" socket
 - 9/16" box and open end wrench
 - 1/4" punch with a 3" shank
 - steel hammer and/or plastic hammer
 - snap-ring pliers that will fit the holes on the snap rings
 - spring scale
 - set of allen wrenches or at least one 1/4" and one 1/8" allen wrench
 - a clamp that spans the distance across the teeter blocks and has 4" jaws minimum
 - one rotor hub shimming fixture. See page 59 in this manual for a drawing of the fixture with dimensions and specifications. This fixture is also available from RotorWay, part number E08-6000.
 - one dial indicator with a 4" reach that reads in thousandths.

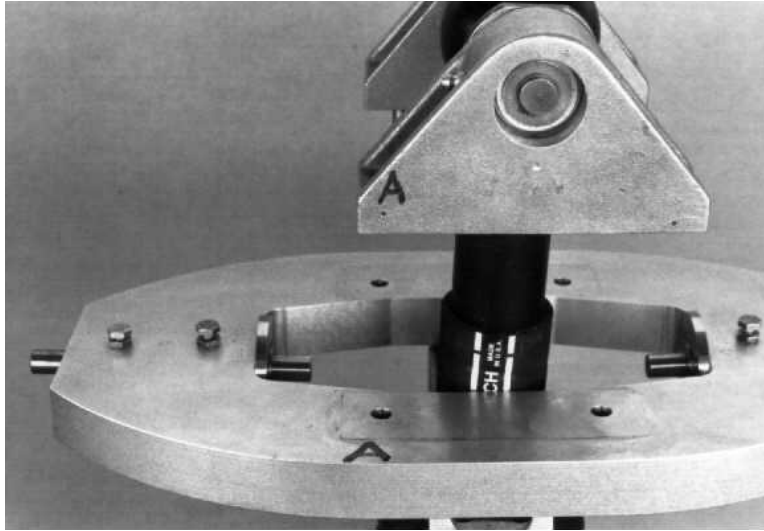
Photo #2: Mark the hub plate, shaft and teeter blocks.

5. Next using the same marking on the hub, mark the shaft in relation to the hub and the teeter blocks. See photo #2.

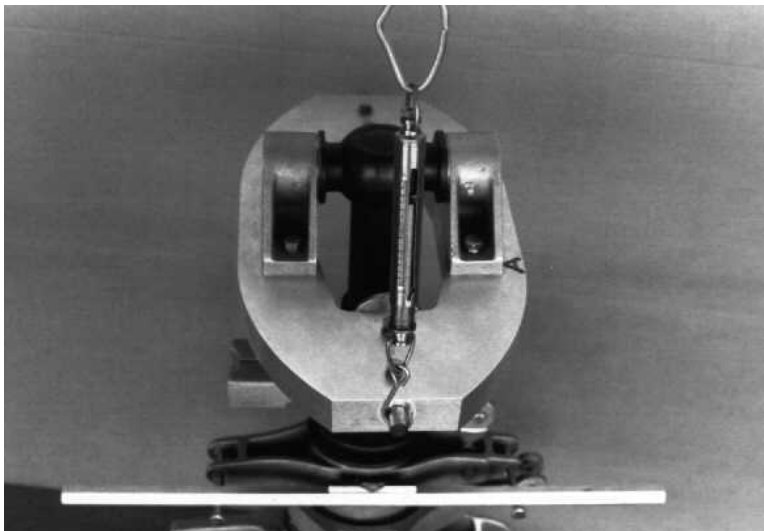
Photo #3: Measuring hub pressure with spring scale.

6. Place the spring scale on the outboard pin and pull up or down until the hub plate starts to move. Read the scale and record the reading for later reference. See photo #3.

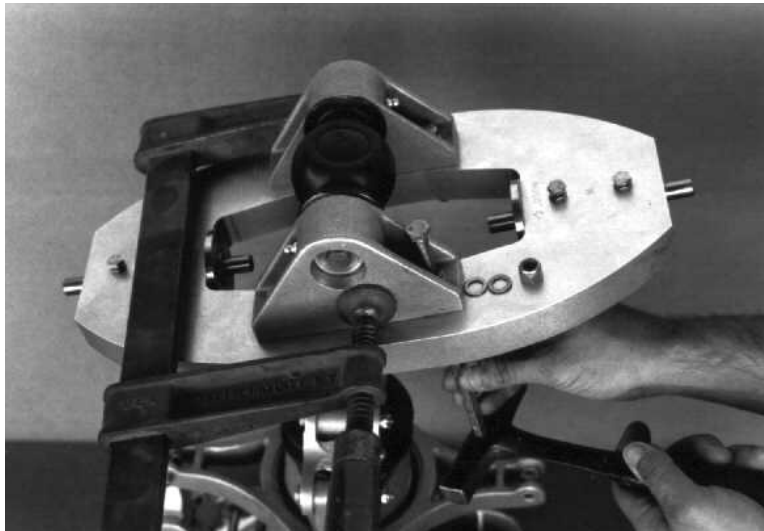
Photo #4: Drive out the teeter block bolts.

7. Place the "C" clamp across the teeter blocks so that the jaws clamp at the base, close to the center of the block (photo #4). Using the 9/16" socket wrench and open end wrench, remove the locking nut from the bolt. After the nut has been removed and washers taken off, place the box wrench on the teeter block bolts. Turn the wrench so that when you tighten the "C" clamp slightly, the wrench will begin to move easily. Tighten the clamp down by feel so that you find the spot where the wrench will move the easiest. Place a small amount of grease on the bolt threads and drive the bolts out through the hub plate with the hammer and punch. **CAUTION:** If the teeter block bolts do not move easily, some of the aluminum will be galled out of the hub plate holes. After the teeter block bolts have been removed, remove the "C" clamp. Remove the two remaining teeter block bolts from the other teeter block and set the hub plate on the counter balance just below the shaft knuckle. Be careful not to scratch or damage the hub plate. See photos #4 and #5.

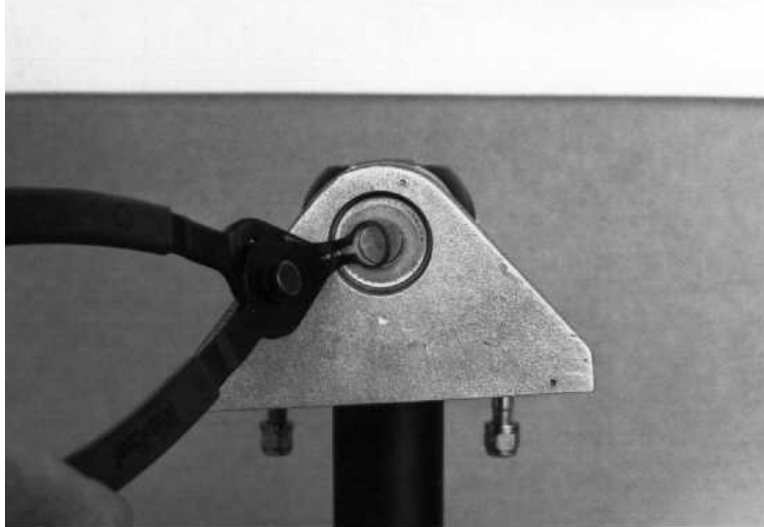
Photo #6: Remove snap rings.

8. Next remove the two snap rings and the large thin washer from the main drive pin. See photo #6.

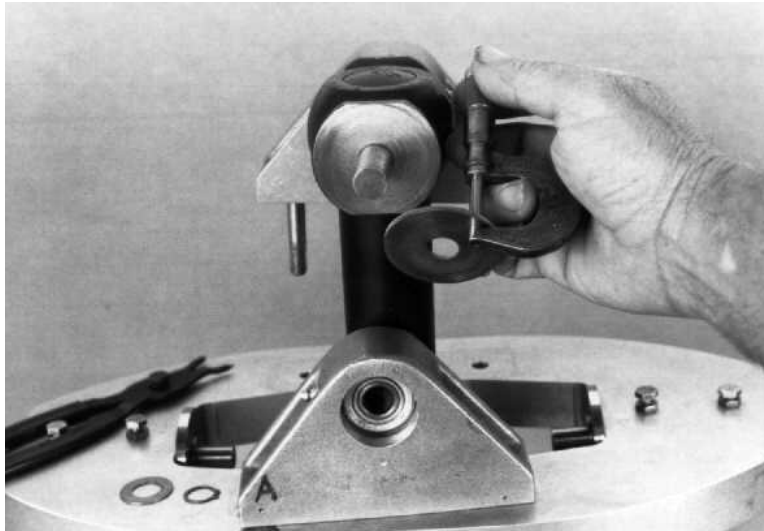
Photo #7: Measure the shims.

- G. Remove the hub plate, inspect the condition and clean. Do not remove your identification markings.
12. Next, carefully remove the steel and delrin shims from the main drive pin. Find a smooth spot on these parts and measure all shims together with a micrometer. (Remember not to mix the pilot and passenger side shims.) See photo #7.

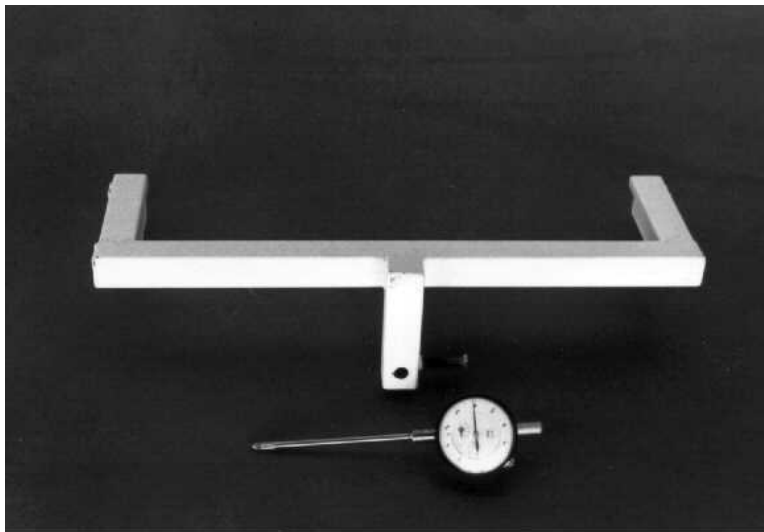
Photo #8: Hub alignment fixture and dial indicator.

24. Rock the hub back and forth 15 to 20 times to set the shims and grease in their respective positions.
25. After reassembly, two objectives must be reached:
 - A. The hub must be on center of the main shaft.
 - B. The hub pressure must be between 8 to 12 lbs.
(This process is difficult to achieve on the first attempt).
26. Measure the hub pressure. Place a spring scale on the outboard pitch pin and pull up or down very slowly until the hub breaks loose and moves. Note the poundage of pull required.
27. Measure the hub to shaft center position by using the hub fixture shown in photo #8. See drawing on page 59.

This fixture is easy to fabricate and will give you very accurate results. Place the fixture on the hub. Push the fixture up against the outboard pitch pins and hold the fixture down on the 3 rivet point contacts located on the bottom. Securely hold the fixture on the hub and rock the hub slightly back and forth until the needle on the indicator stops moving in a central position. Then zero the indicator. Carefully remove the fixture and place it on the other side of the hub using the same procedures. Repeat the steps and determine how far the hub is off center, if any, and which direction it needs to move. If all procedures were done correctly, you should not be any more than .002 to .004 off center and hub pressure will still be within tolerance. Make a note on paper and determine which teeter block should be removed to center the hub on the shaft. Change the stainless steel shims as necessary, following the procedures as previously outlined. The tolerance and specs that must be achieved are:

- A. Hub centering is within .001 T.I.R.
- B. Hub pressure should be 8 to 12 lbs.

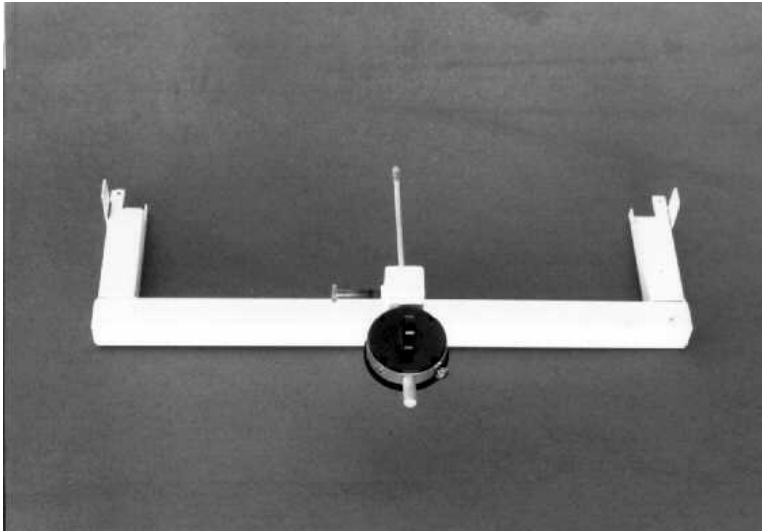
Photo #9: Hub alignment fixture.

When the hub is correctly centered and hub pressure is within the limits specified, final assemble the hub. See photos #9 through #13.

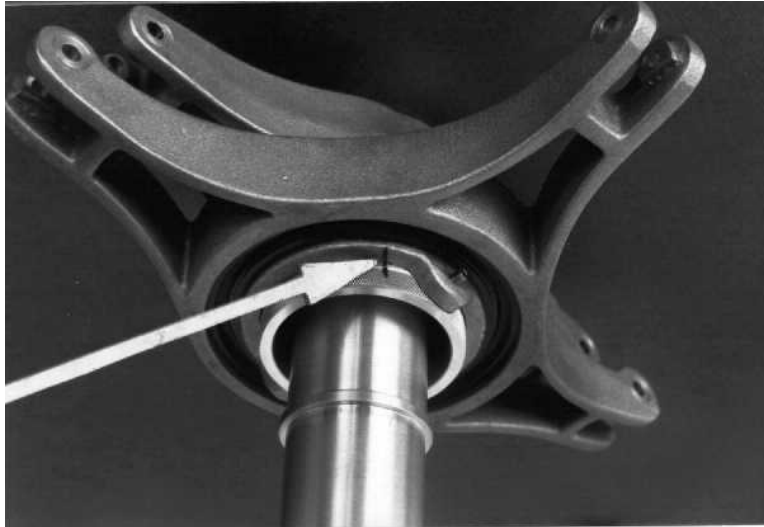
Photo #14: Placing an index mark.

1. Using a protractor level, set the swash plate perpendicular to the main shaft. Rotating the blades may help you in achieving the fore and aft angles. If a protractor level is not available, centering the cyclic stick should place the swash plate at a relative perpendicular angle to the shaft. Loosen the two set screws (part no. E00-9302, Ref. 16 on print E49-2002) three full turns. With your fingers, loosen the adjustment collar approximately 2 full turns in a counter clockwise direction, until it can be turned easily. Again using your fingers, turn the collar in a clockwise direction until it comes to a stop. Make an index mark on the adjustment collar and non-rotating swashplate with a pencil or marker. Back off the adjustment collar counter clockwise 1/2". Then tighten the two set screws. See photos #14-16. Note: Use silicone on the set screws to help lock them in position and prevent them from backing out. Do NOT use loctite.

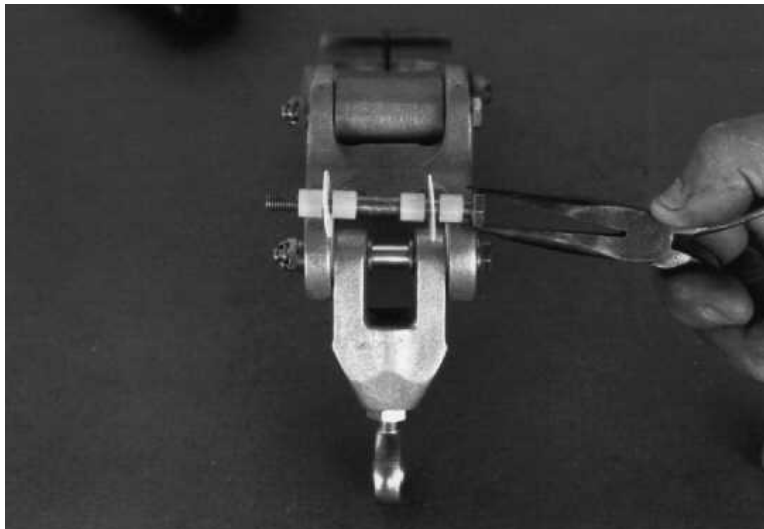
Photo #17: Position of bushings.

Photo #17 illustrates the positioning of the nylon bushings in the swash plate assembly. To determine if the castings need new bushings, measure the lateral deflection of the parts. If a total of .125 inch or greater is indicated, the nylon bushings should be replaced. The maximum the castellated nut should be tightened is two flats past finger tight. Further tightening may damage the aluminum castings.
