EXEC 162F MAINTENANCE MANUAL

The RotorWay EXEC 162F Maintenance Manual has been designed to provide the owner-operator the lowest operating cost possible while maintaining the flight characteristics and safety of their helicopter.

INTRODUCTION

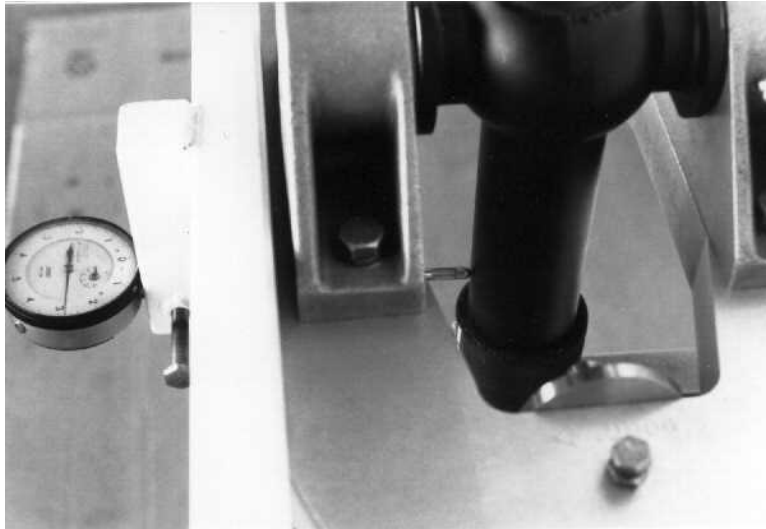
When the hub is correctly centered and hub pressure is within the limits specified, final assemble the hub. See photos #9 through #13.

Photo #9: Hub alignment fixture.

Photo #10: Hub fixture located on hub.

Photo #11: Proper placement of hub fixture.

Photo #12: Dial indicator reading on center of main shaft.

Photo #13: Reading poundage pull on hub.

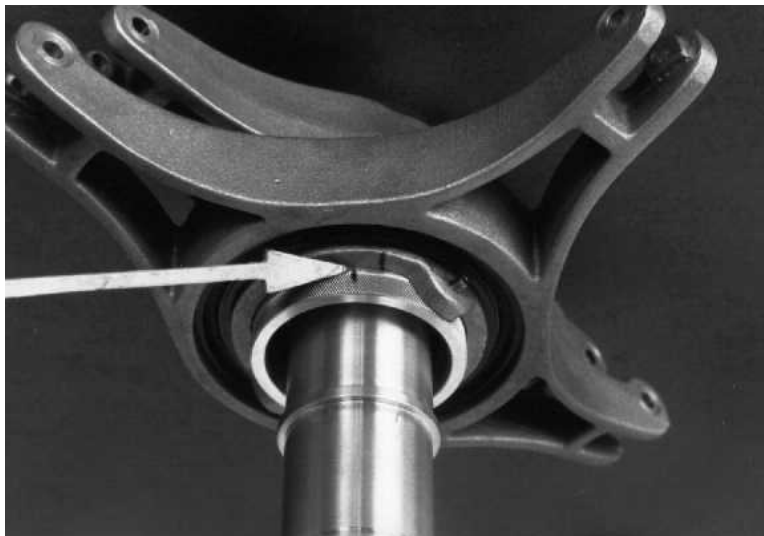
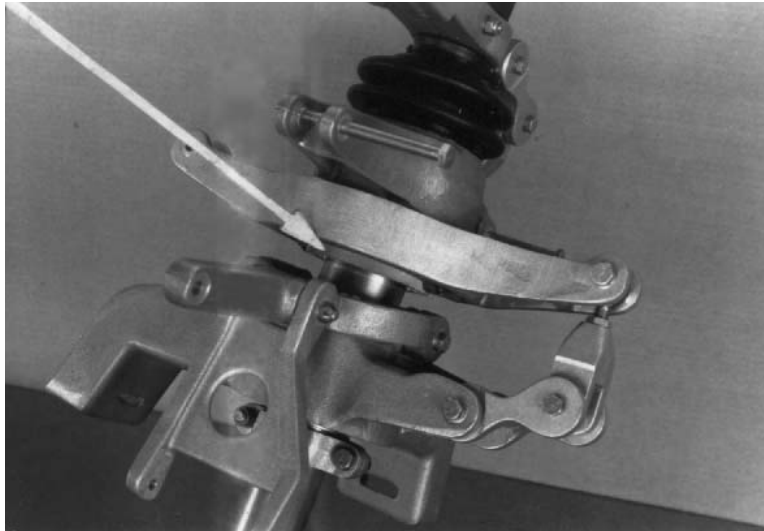
1. Using a protractor level, set the swash plate perpendicular to the main shaft. Rotating the blades may help you in achieving the fore and aft angles. If a protractor level is not available, centering the cyclic stick should place the swash plate at a relative perpendicular angle to the shaft. Loosen the two set screws (part no. E00-9302, Ref. 16 on print E49-2002) three full turns. With your fingers, loosen the adjustment collar approximately 2 full turns in a counter clockwise direction, until it can be turned easily. Again using your fingers, turn the collar in a clockwise direction until it comes to a stop. Make an index mark on the adjustment collar and non-rotating swashplate with a pencil or marker. Back off the adjustment collar counter clockwise 1/2". Then tighten the two set screws. See photos #14-16. Note: Use silicone on the set screws to help lock them in position and prevent them from backing out. Do NOT use loctite.

Photo #14: Placing an index mark.

Photo #15: View after the collar has been backed off.

Photo #16: Tighten set screws in collar.
